Unplanned Interruptions Report

for the assessment period ended 31 March 2024

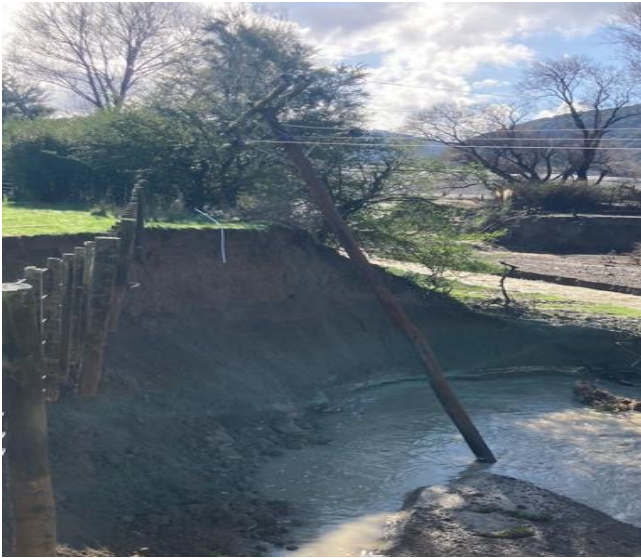
Photograph 1: Pole damaged by a slip

Photograph 1 shows a pole made unstable by a slip and Photograph 2 shows the scale of the slip on Te Hau Road, Whatatutu, which was caused by heavy rain during the storms on 28 June 2023 (major event details can be found in section 5 on page 49).

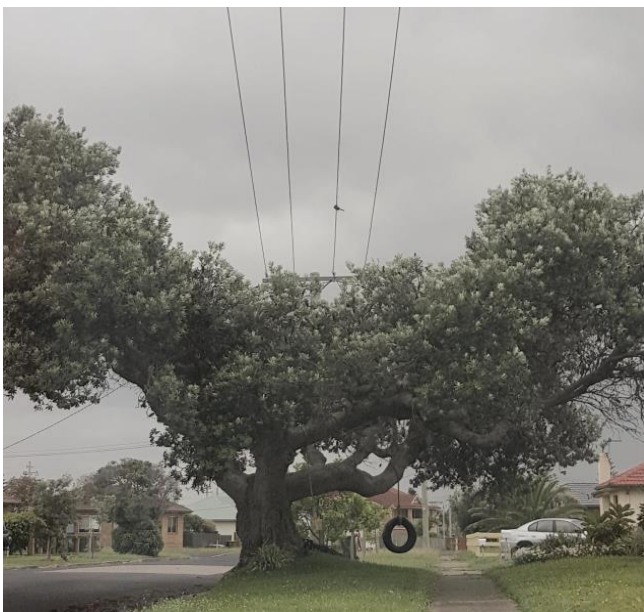
Photograph 3: Example of a tree trimmed to a ‘clear to the sky’ policy

An example of a tree trimmed under a clear-to-sky policy is shown in Photograph 3. While the amendments to the tree regulations are intended to reduce interruptions to supply, we believe that had the amendments been in place during Cyclone Hale and Gabrielle or even more recently, i.e., this assessment period, there would have been very little change in our overall performance. This is because the trees that caused the interruptions were largely outside the GLZ and were plantation-owned.
