Unplanned Interruptions Report

for the assessment period ended 31 March 2024

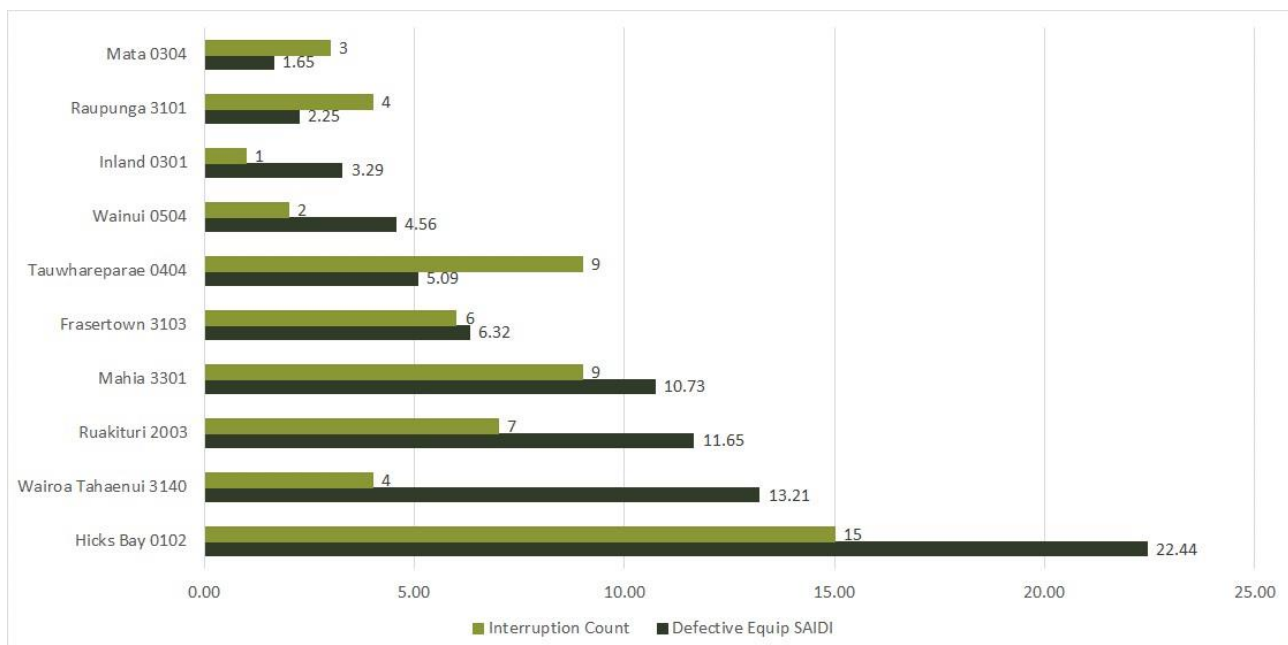
Graph 23: Defective equipment SAIDI and interruption count for the worst-performing feeders

PBA advised that without a specific inspection programme to check the condition of the spans, not just at support points or terminations, the asset renewal programme is likely based on an age assessment only, which has significant risks associated with it. PBA recommended that we build a conductor inspection programme around the following:

- i. Asset type and age—conductor construction, i.e., strengthening cores, strands, insulation, and materials
- ii. Environmental conditions, i.e., coastal, wind, temperature range/extremes
- iii. Consequence of failure, i.e., public safety, livestock, property damage, including forest fire, and others.

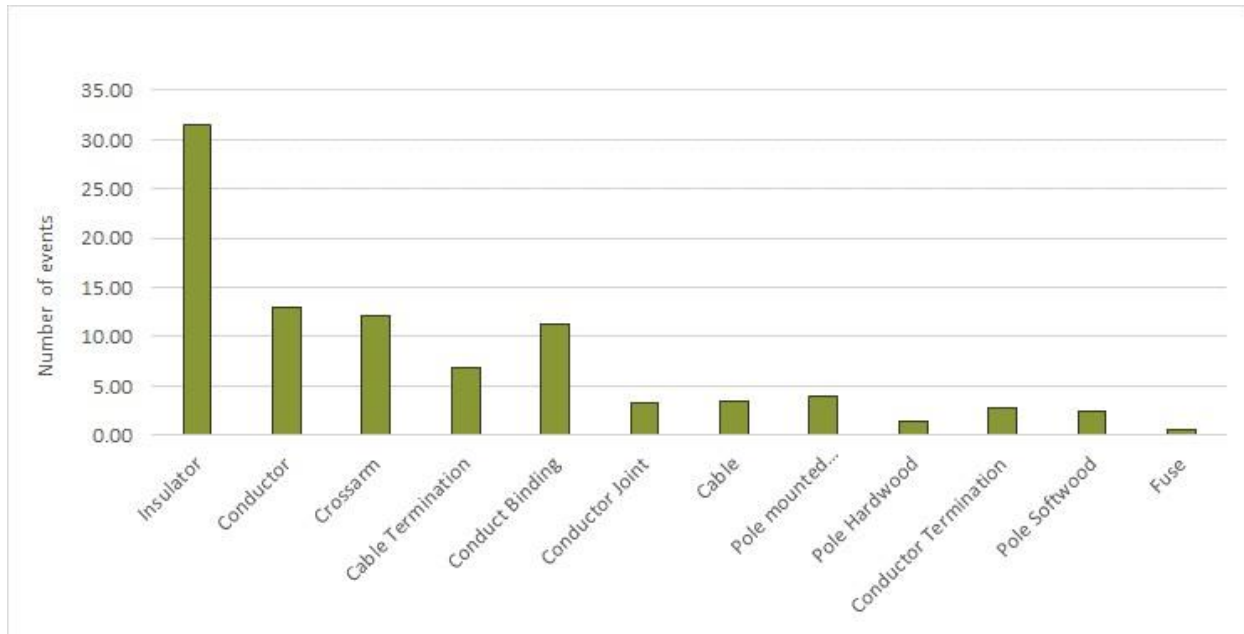
Graph 24: Defective equipment breakdown for the ten worst-performing feeders

Single-strand steel conductors are among the highest-risk assets in the conductor asset class due to their age and likelihood of failure under wind loading and highly corrosive environments (coastal). Accordingly, PBA further recommended that we assess the likelihood of failure with the consequences and create a set of controls to mitigate the risk and reduce the residual risk to the lowest practical level.

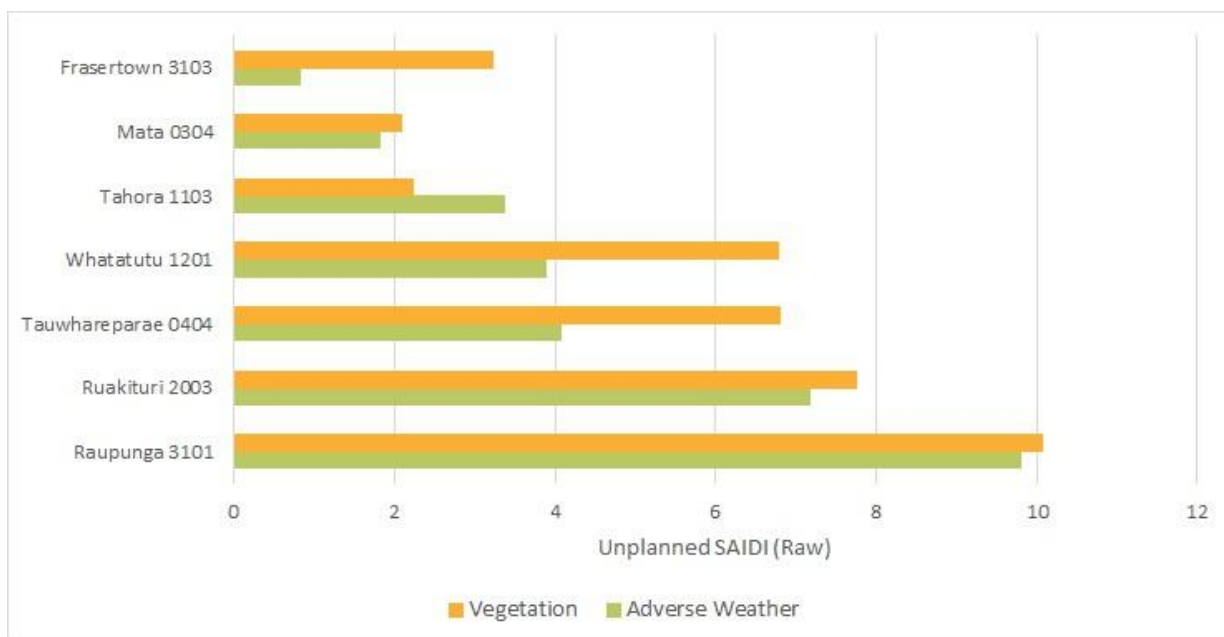
Graph 25: Correlation between adverse weather and vegetation caused interruptions

Graph 25 shows the correlation between unplanned SAIDI caused by Adverse weather and Vegetation.

It demonstrates that the same feeders impacted by adverse weather also have vegetation control challenges. Making a case for an increase in inspection frequency and negotiating an increase in vegetation corridor width (clearance requirements) to protect the electrical network and minimise the residual risk of forest/vegetation fires caused by vegetation contacting electrical assets.

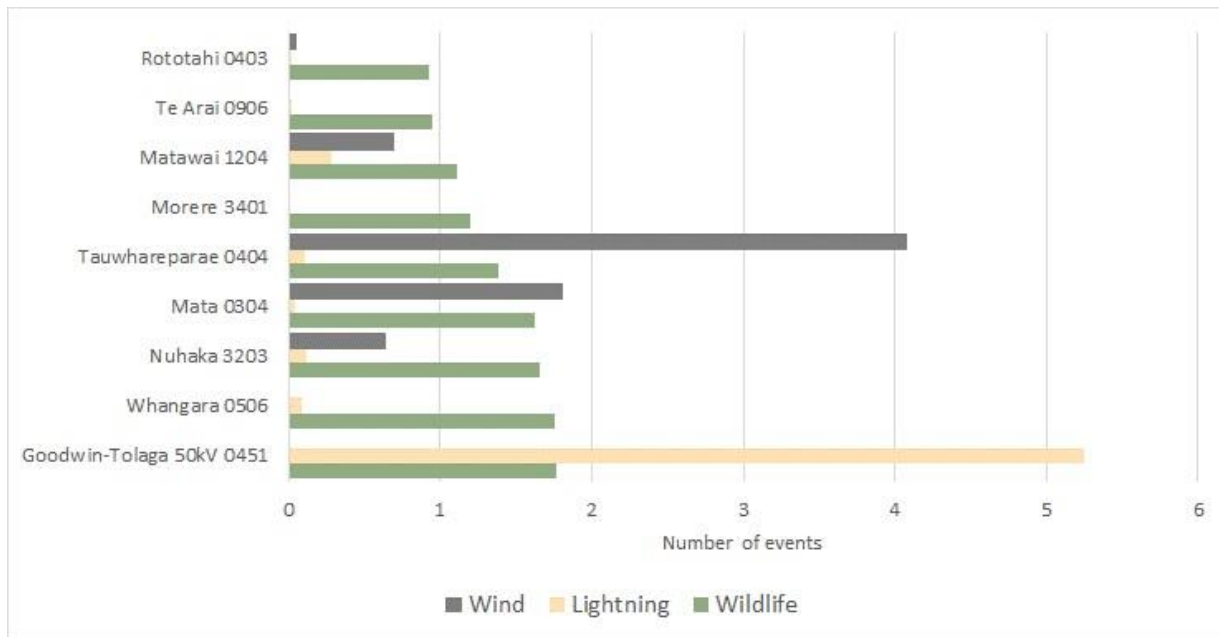
Graph 26: Correlation between wind, lightning, and wildlife caused interruptions

Graph 26 shows unplanned SAIDI caused by Wind, Lightning, and Wildlife. For the worst-performing feeders, 97.8% of unplanned SAIDI caused by wildlife was caused by bird strikes. There seems to be a correlation between feeders that experience adverse weather (wind) and Lightning events and the number of bird strikes on feeders.

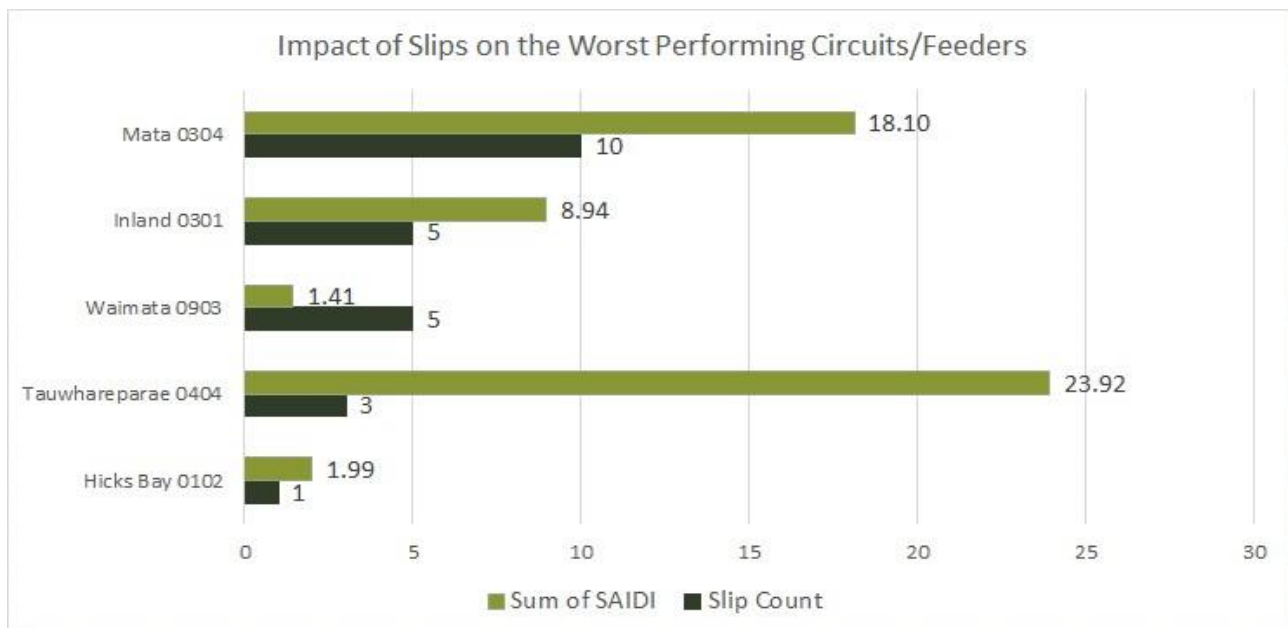
Graph 27: Impact of slips in the worst-performing circuits/feeder

Graph 27 shows that five out of ten of the worst-performing feeders (i.e., 50%) were hit with slips, causing unplanned SAIDI.

Access constraints after cyclones Hale and Gabrielle in January 2023 delayed fault restoration. In some cases, the roads in the area remain closed or dangerous for after- dark fault crews to navigate. This has resulted in us postponing restoration work until the following day when it is safe to traverse the route.

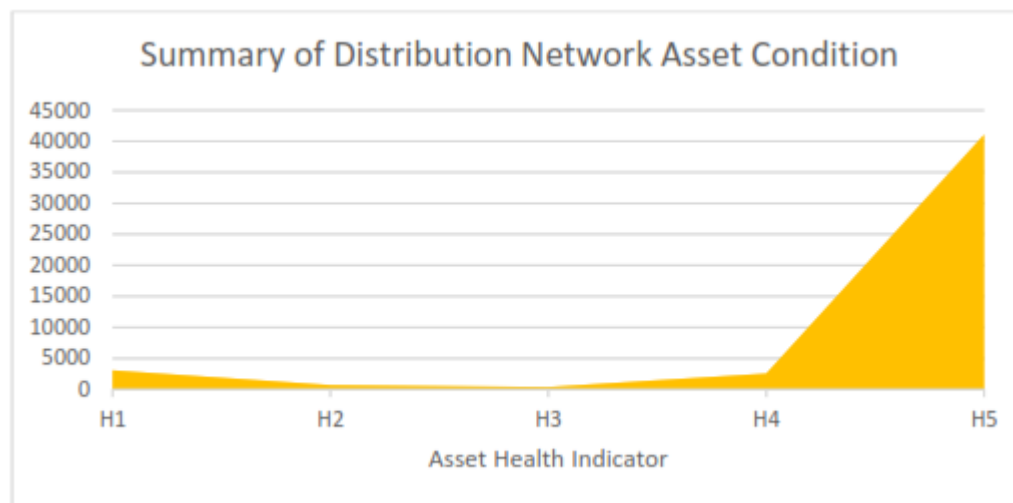
Graph 28 Summary Distribution of Network Asset Health

Graph 28 indicates, based on our Asset Health methodology, that most of our network is in good health. It is expected that asset health scores will increase in accuracy.

Reviewing our asset records, PBA expected a broader range of conditions, with a larger number of assets scoring H3 and H4. As we complete our asset inspection programmes, asset health scores are expected to increase in accuracy.

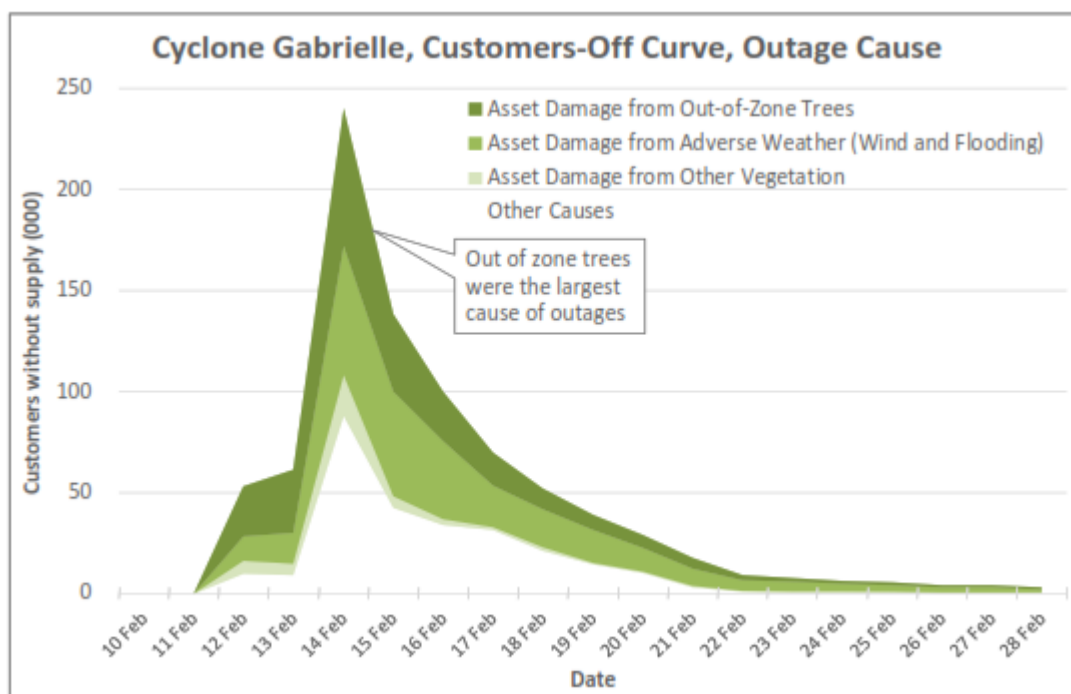
Graph 29: Material causes of customer outages extract from the energia report²¹

Energia determined that the largest cause of outages for EDBs was out-of-zone tree damage. The second largest cause was high winds causing damage to overhead lines, followed by flooding damaging assets (including substations), as shown in Graph 29.²⁰

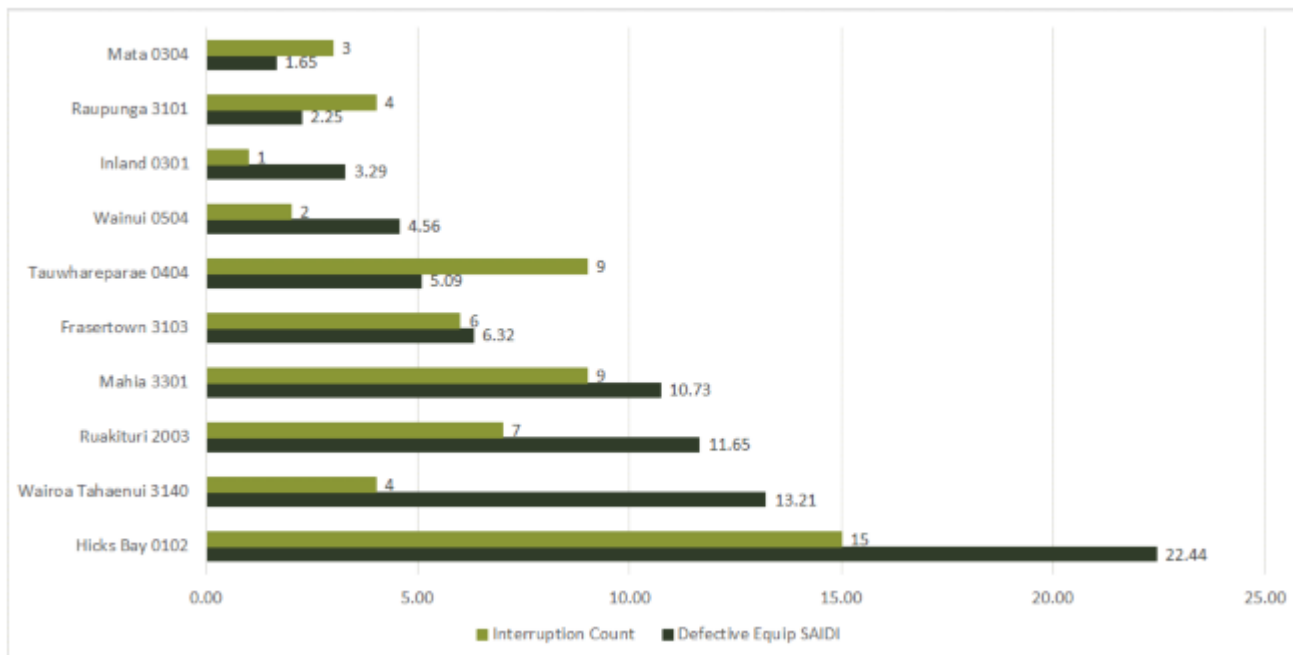
Graph 33: The number of interruptions caused by defective equipment and SAIDI by feeder

Graph 33 shows the number of defective equipment interruptions (events) and the associated planned SAIDI by the ten (10) worst-performing feeders.

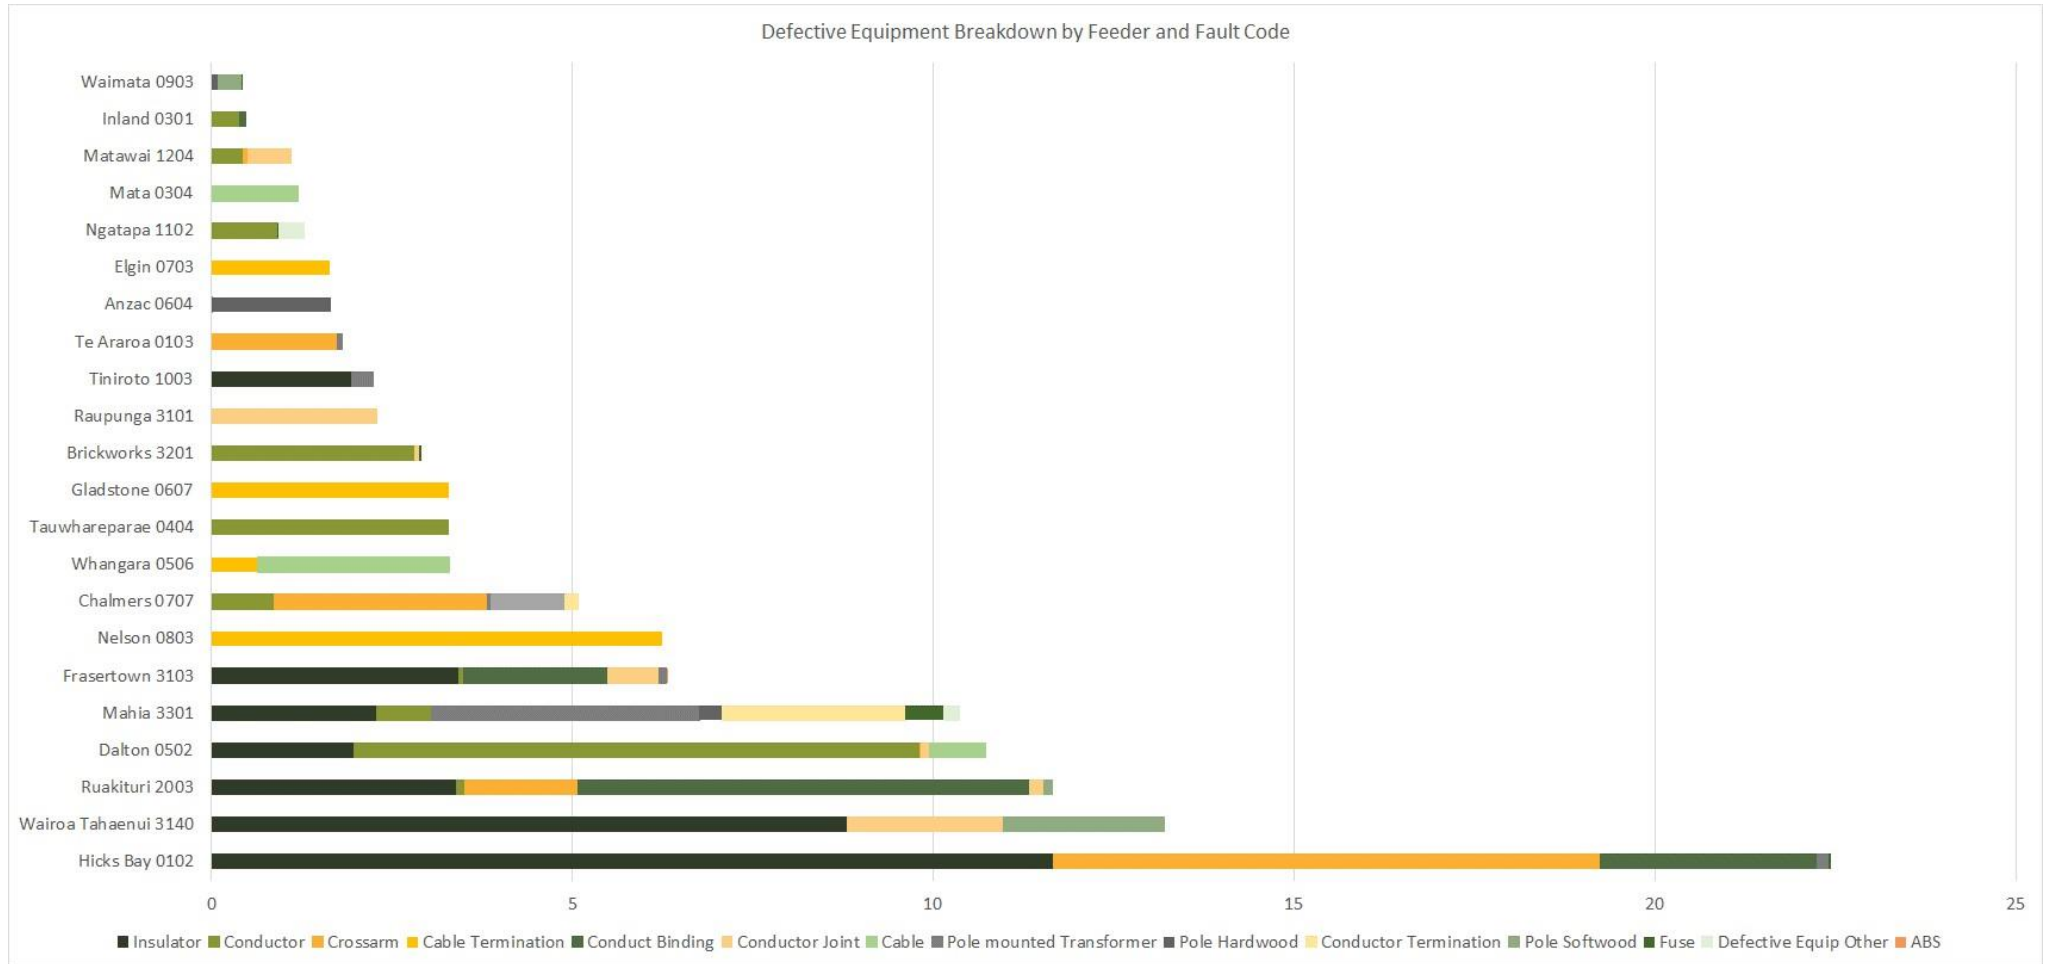
Graph 34: Defective equipment breakdown by feeder and fault code

Graph 34 shows the main equipment involved for those interruptions caused by 'defective equipment' by the feeder. Insulators, conductors, conductor binding, and joint failure were the most frequent of the main equipment categories. This is largely due to the location of the faults in the network (i.e., distance and access constraints on specific feeders) and the challenge of locating faulty insulators.

Four (4) feeders accounted for the highest SAIDI (Frasertown, Ruakituri, Wairoa, and Hicks Bay); for these feeders, the highest contribution to SAID was from faults on insulators. This is not surprising as damaged insulators can be difficult to locate and, therefore, incur longer restoration times.

Eight (8) out of the worst ten (10) feeders significantly contributed to unplanned SAIDI caused by Conductor bindings, Terminations, Joints, or the Conductor itself failing.

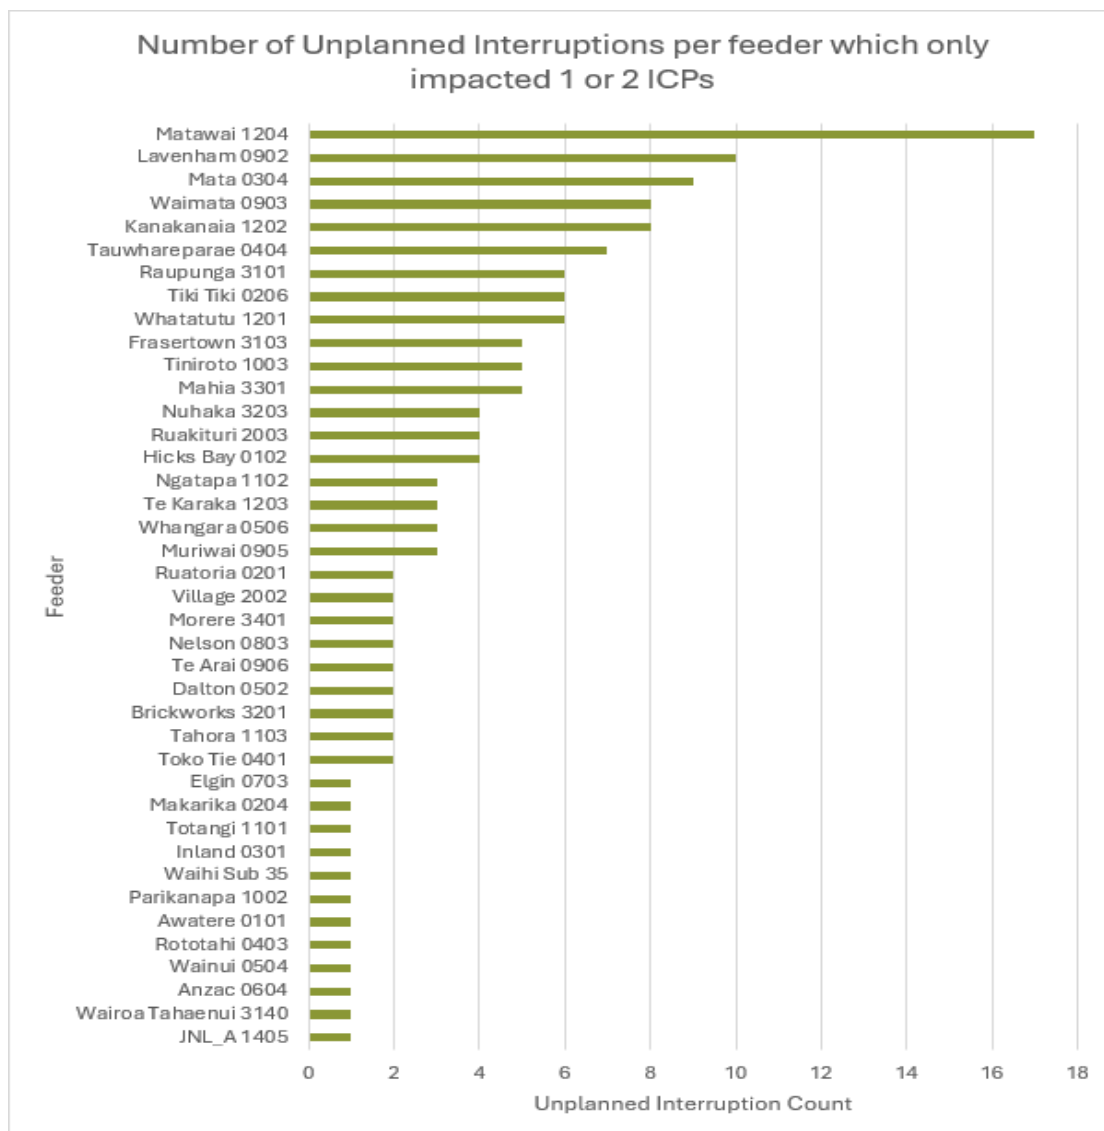
Graph 38: Number of Unplanned Interruptions per feeder that impacted 1 or 2 consumers

Of the total Unplanned Interruptions on our network during the assessment period, 102 interruptions disrupted supply to one consumer, accounting for 46.49 of our total SAIDI minutes, and 44 interruptions disrupted supply to two consumers, accounting for 23.68 of our total SAIDI minutes. Graph 38 shows the number of unplanned interruptions that impacted one or two consumers.

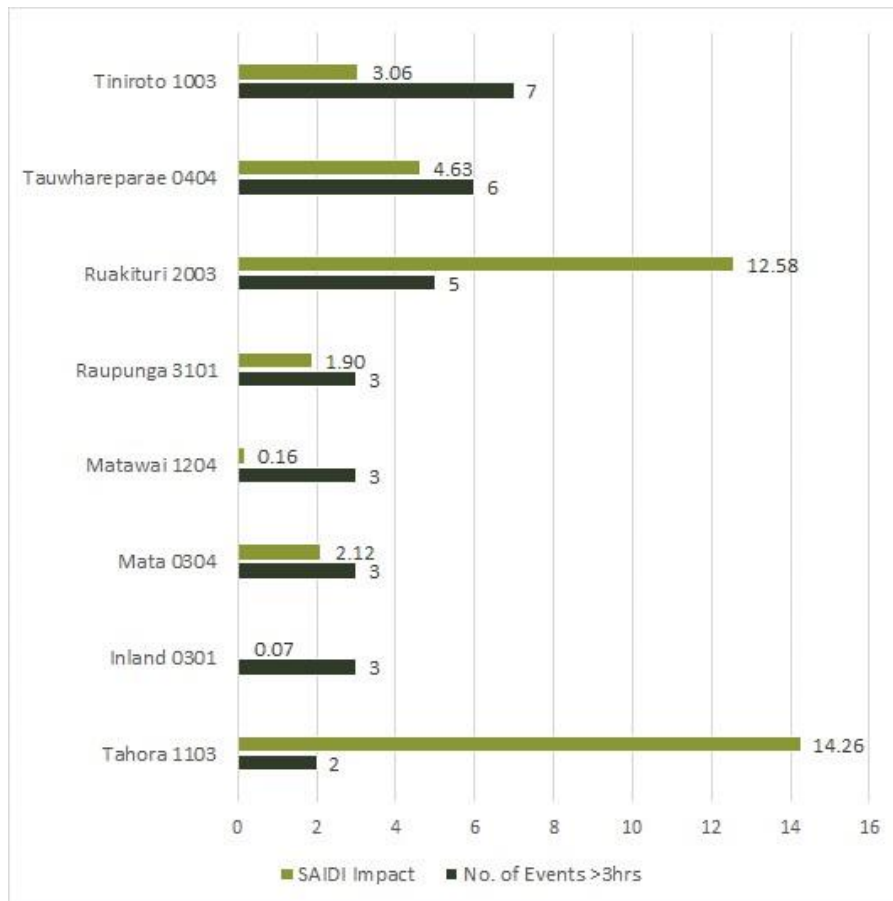
Graph 39: Overnight Interruptions by Feeder (SAIDI vs. Number of Interruptions >3hrs duration)

Graph 39 shows the number of interruptions and SAIDI by feeder that occurred overnight and were greater than 3 hours in duration.

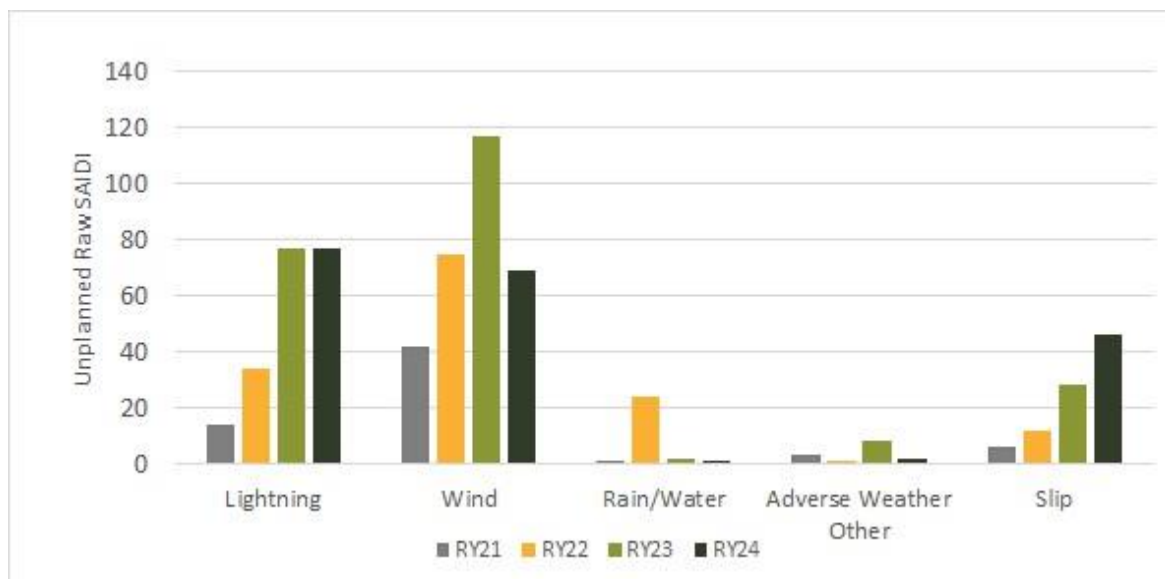
Graph 40: Four-year Adverse Weather and environmental events trends

Graph 40 shows a step change in adverse weather and environmental events over the last three years, contributing significantly to interruptions and our SAIDI minutes in the assessment periods.

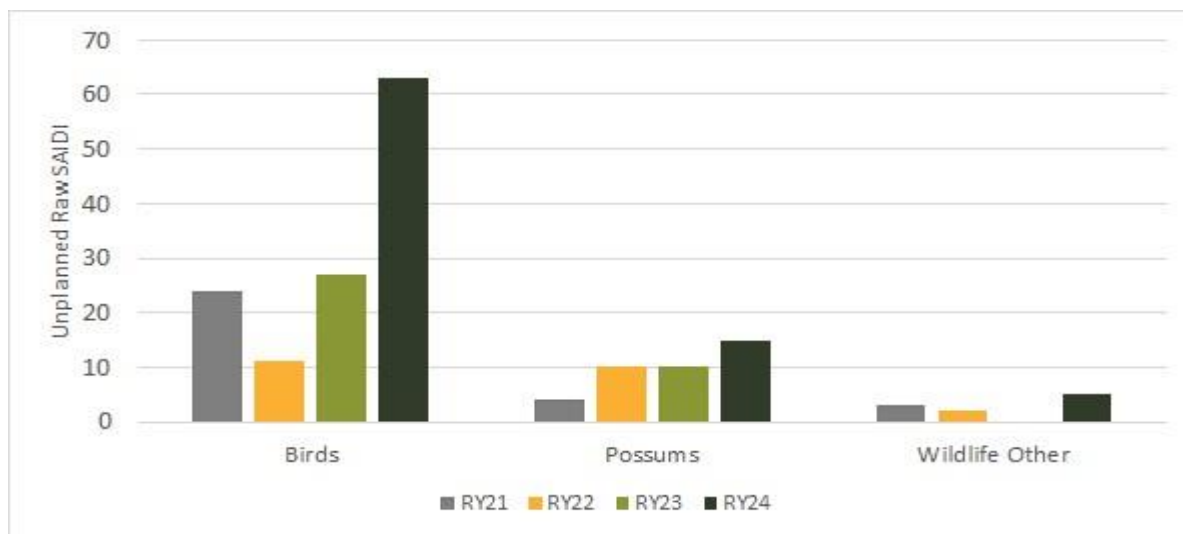
Graph 41: Four-year Wildlife event trends

An increase in Adverse weather and environmental events has an impact on wildlife activity, as shown at Graph 41. Despite a significant 1080 drop in targeting possums, the interruptions caused by possums are on the increase.
